CONTRACT REPORT BRL-CR-539

**SURVEY OF NONDESTRUCTIVE METHODS  
FOR EVALUATING DERAILED TANK CARS**

Materials Science Division  
Idaho National Engineering Laboratory  
Idaho Falls, Idaho 83415

November 1984

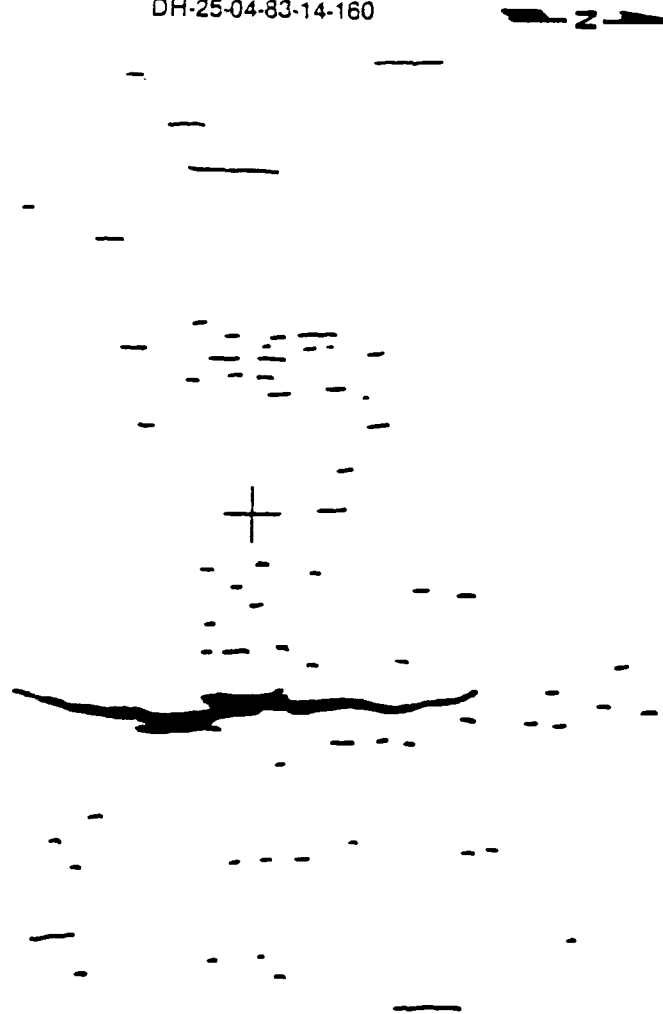
Figure A-3c. Map of Surface Cracks on the Convex (Bottom) Side  
(DH-25-04-83-14-160)
